CONNECTICUT RIVER BASIN
BLOOMFIELD, CONNECTICUT

**COLD SPRING RESERVOIR DAM
CT 00495**

**PHASE I INSPECTION REPORT
NATIONAL DAM INSPECTION PROGRAM**

MAY 1981

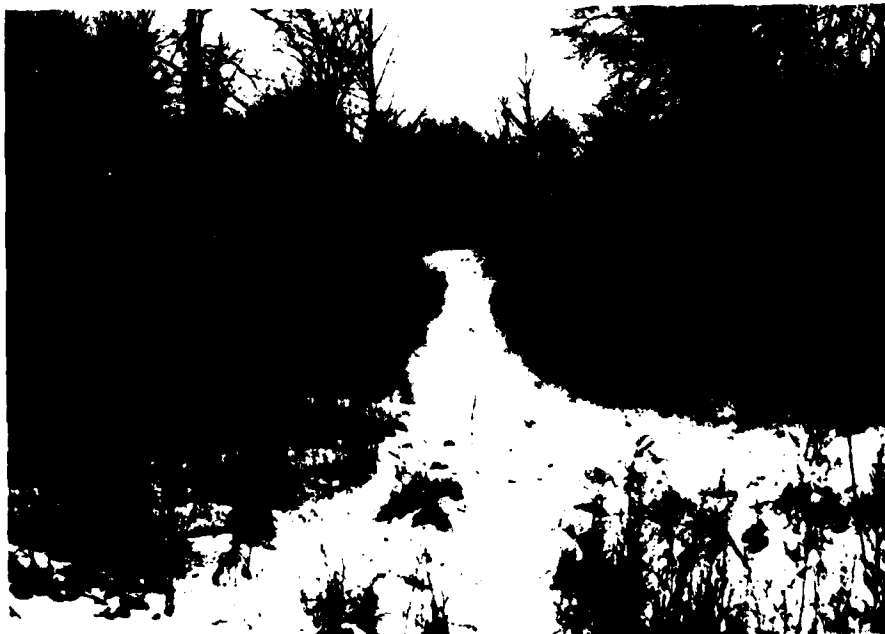
The dike is a low grass covered earthfill embankment located at the northeast corner of the reservoir, and appears to be used as a farm road (See sheet 2, Location Plan, for dike location). Severe vehicular rutting and very minor slope erosion was observed respectively, along the crest and slopes of the dike embankment. The upstream and downstream slopes and toes were moderately covered with brush and small trees as shown in Photo 8.

PHOTO 8 - View looking south along
minor dike.

It is recommended that the owner repair the wheel ruts, low spots, and minor erosion gullies on the crest and slopes of the dam and dike embankments within one year of this report. Other remedial measures contained in Section 7 should also be carried out within a period of one year.
